ANNUAL REPORT

1992

Transportation Safety Board  
of Canada

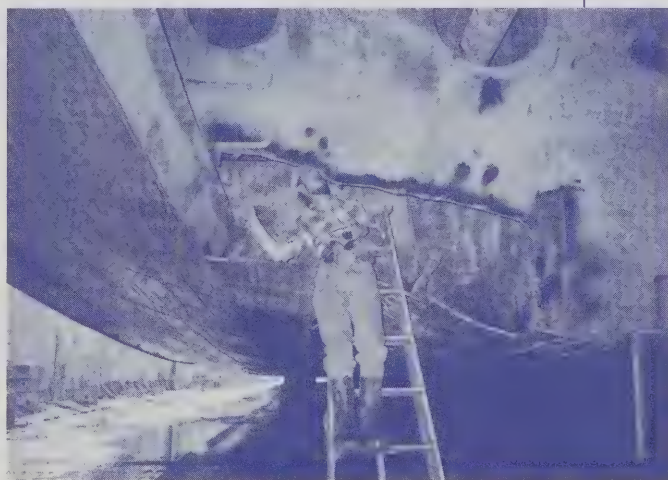
At high tide, the vessel was refloated. An underwater survey indicated extensive bottom damage; a bunker oil tank adjacent to the most severely damaged area was also dented but not breached. There is no dry dock large enough to accommodate the 292 m long vessel in the area.

*A hull survey indicated extensive bottom damage to the "Concert Express".*

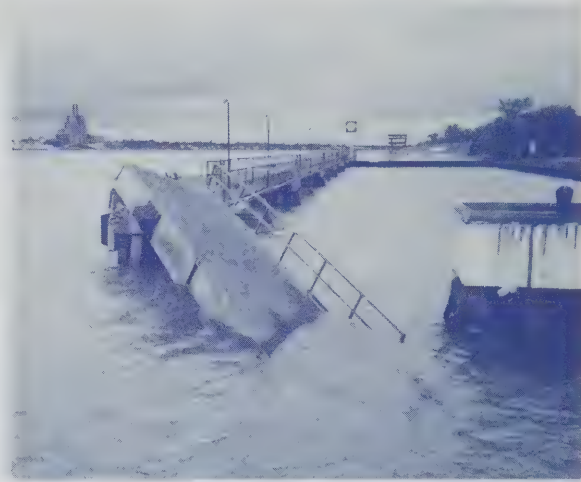
The 19,160 gross ton, 219 m long Canadian bulk carrier "Ralph Misener", with a cargo of 25,105 tonnes of iron ore pellets, was berthing at the Shell Oil dock in Sarnia, Ontario, for fuel. At 0400 on 8 August 1992, she struck the north-west corner of the dock, dislodging some 30 m of catwalk which fell into the river. The starboard side of the vessel sustained a 4 m X 3 m hole above the 27 ft. (8.23 m) draught mark. A 2 inch (5 cm) shore diesel line was also damaged, but since it had been isolated there was no pollution. There were no injuries. The dock was considered unusable

*Extensive damage was reported, but there was no pollution.*

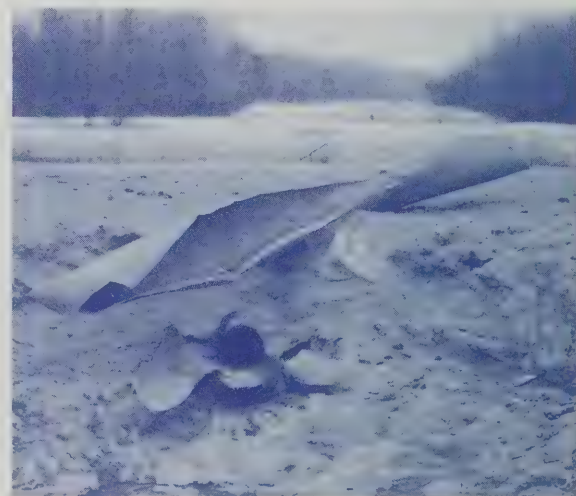
The investigation quickly revealed that the wall of the pipeline had failed in ductile overload, under normal operating pressure, after a progressive precrack had grown to critical size.

The mode of crack generation was identified in the field as stress corrosion cracking. The information was passed to the pipeline

*The occurrence created a blast-affected zone approximately the size of a football field.*

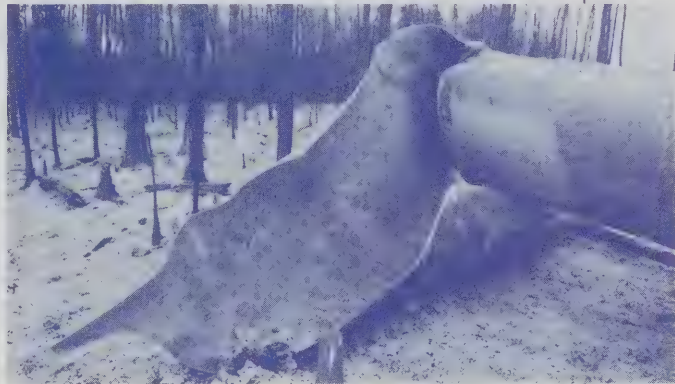
This occurrence marked the third time in 18 months that stress corrosion cracking had apparently resulted in an in-service gas pipeline rupture in Ontario. The previous two cases were on 8 December 1991 near the village of Cardinal and on 17 January 1991 near the town of Cochrane. These three occurrences indicated a recurrence of a problem with stress corrosion cracking previously experienced in 1985 and 1986.

*General views of the failed section of buried main natural gas pipeline showing fire and explosion damage.*

repairing stress corrosion cracks and to operating procedures where such cracks are known or suspected to exist.

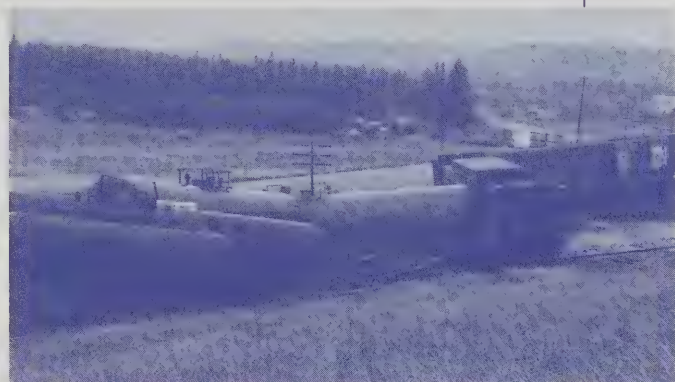
On 9 July 1991, a multiple-car derailment occurred at Mile 204.39 on the CN Rivers Subdivision near the town of St. Lazare, Manitoba. The accident occurred when an express train entered an unstable section of track where defective track ties were being replaced. Twenty-two cars, including some containing dangerous goods, were derailed. The cause of the derailment was a track buckle which resulted from a combination of lateral instability of track after tie renewal, thermal expansion of the rail, and dynamic loading of a heavy train at a speed excessive for the track conditions.

*Leakage from acetic anhydride and caustic soda cars resulted in evacuation of the town of St. Lazare (476 residents) for seven days.*

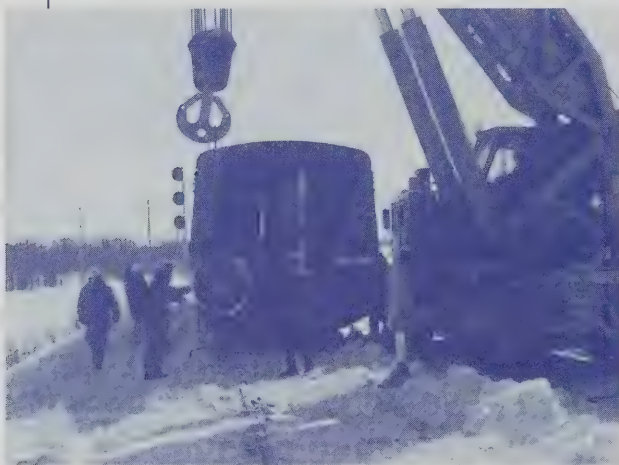
Three separate accidents involving broken axles on VIA Rail LRC passenger trains occurred between January 1991 and March 1992. Because the safety problem could not be readily identified, the Board recommended special inspections of all LRC axles in an attempt to identify those in an early stage of failure before fracture occurred. The entire fleet of LRC cars was voluntarily taken out of service by VIA Rail and all axles were inspected. Several more cracked axles were discovered through this process.

*The entire fleet of LRC cars was voluntarily taken out of service by VIA Rail and all axles were inspected.*

As a result of this investigation, the Board made five recommendations regarding axle design, manufacture and maintenance, intended to prevent a recurrence of axle failures on LRC equipment. Subsequently, VIA Rail replaced every axle on LRC equipment with new axles.

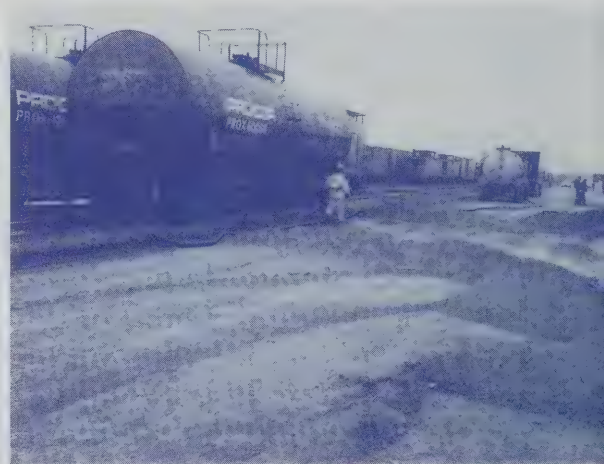
On 30 April 1992, a switching incident in a hump yard resulted in a spill of a large quantity of sulphuric acid when a car from a unit acid train was switched by an inexperienced employee working without direct supervision. The heavy impact at coupling caused serious structural damage to one of the loaded tank cars allowing the contents of the car to spill onto the ground.

*Humping procedures and training programs are some of the safety issues under consideration by the Board.*

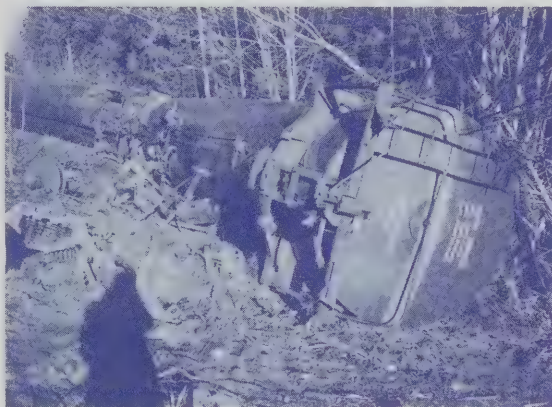
In several freight train derailments investigated during 1992, a contributing factor was determined to be certain worn truck components on leased tank cars which led to loss of suspension damping. The defects were not being detected during normal train inspections because the condemning limits apply to the amount of wear on components individually and not in combination. More thorough examinations and repairs of truck components were

*The Board recommended the establishment of condemning limits for combination truck component wear for all leased cars on federally regulated railways.*

The Board recommended the establishment of condemning limits for combination truck component wear for all leased cars on federally regulated railways. The Board also recommended that the Department of Transport participate with the railway industry in improving the system of cost recovery to include the replacement of components on leased cars when combination truck component wear exceeds specified limits. The Minister of Transport accepted the first recommendation, but rejected the second because cost recovery within the private sector

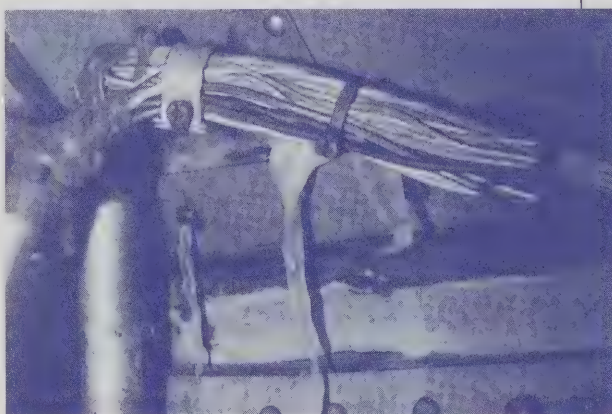
The investigation revealed that water and melting ice had leaked through the left over-wing emergency exit door seal and collected in the belly of the aircraft. When the aircraft was pressurized in flight, the water was forced out onto the aileron pulleys in the left wheel well where it froze, jamming the aileron and the speed brake controls.

*Close-up view of area "B," icicle on the slant panel dripping onto the aileron pulley bracket.*

As a result of the involvement of the U.S. Accredited Representative, the NTSB recommended that the FAA issue an Airworthiness Directive requiring the installation of a water drain system in the main landing gear wheel wells on all applicable DC-9 and MD-80 series aircraft.

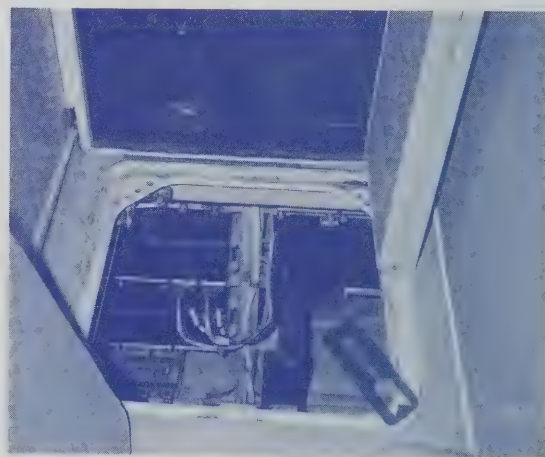
*Water was found on the floor of the electrical and avionics bay.*

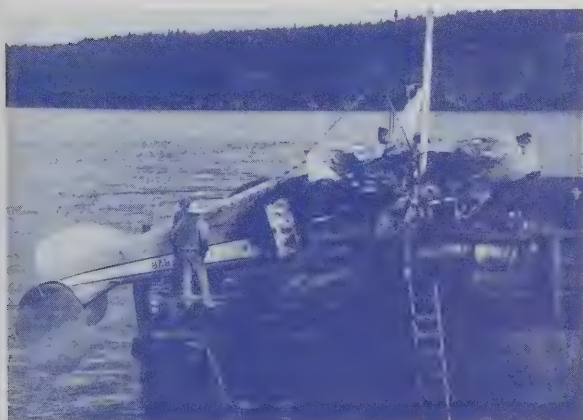
*Examination of the wreckage revealed a passenger seat with both supports detached from the seat track fitting.*

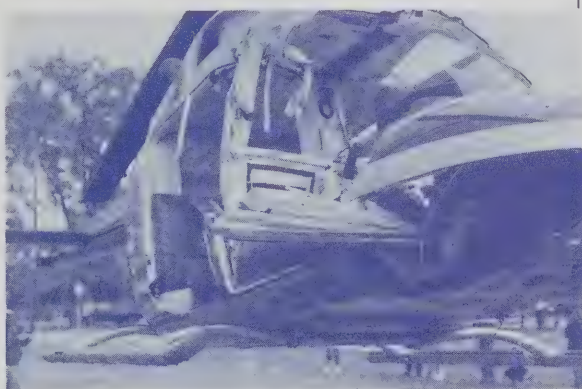
*The Bell 206 was significantly damaged, but the pilot was able to land safely in a vacant parking lot.*

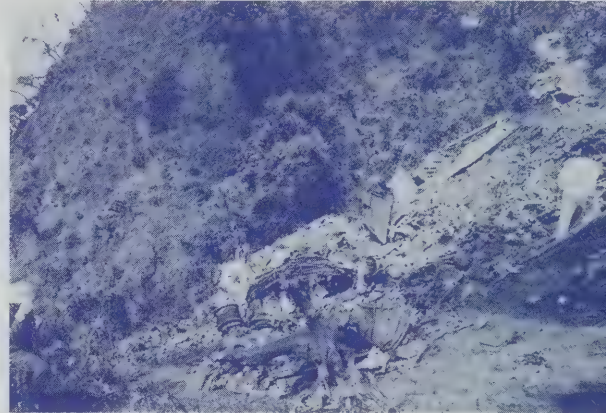
Accident site on hillside at approximately 7,500 feet above sea level and some nine nautical miles from Tribhuvan International Airport in Kathmandu.

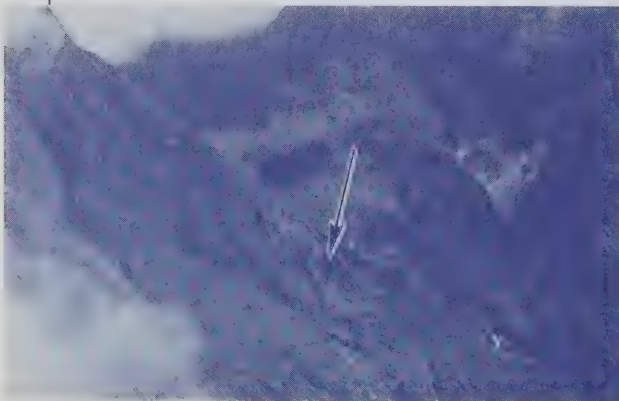
A310 accident site. Arrow indicates impact point.

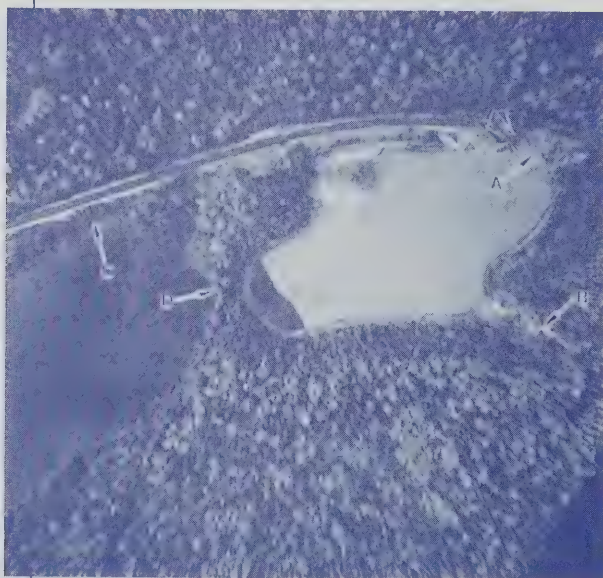
*Vertical aerial photo showing track bed failure at "A" caused by a rapid failure of a beaver dam at "B"; stereo aerial photo interpretation of the scene and surrounding area revealed another location along the track at "C" which could fail in a similar manner if the beaver dam at "D" failed.*

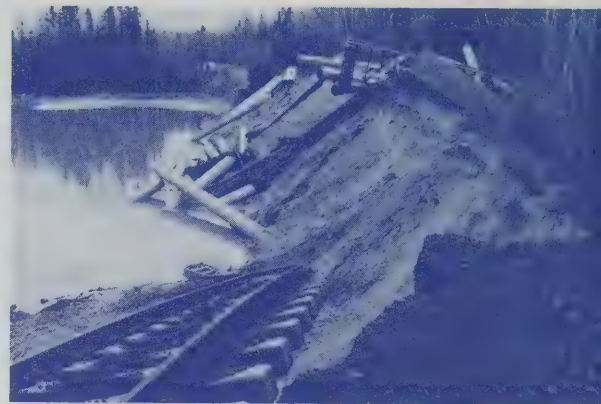
*General view of the failed track bed at location "A" showing the derailed freight train.*

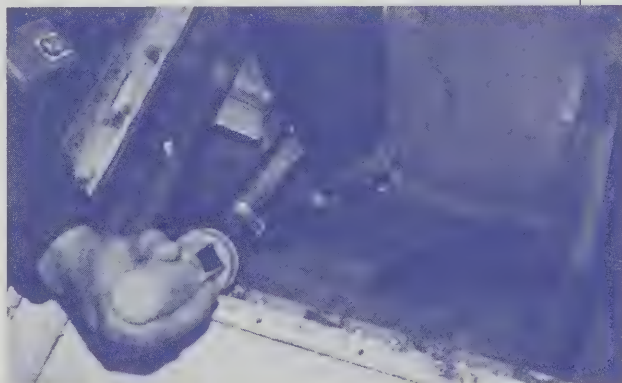
Water and ice which had pooled in front of the slant panel.
